SUBJECT: Site & Reach Assessment / Evaluation of Treatment Alternatives  
SR 8 MP 15.33 (Kennedy Creek) CED Site

# **Site & Reach Assessment and Evaluation of Treatment Alternatives SR 8 MP 15.33 (Kennedy Creek) CED Site**

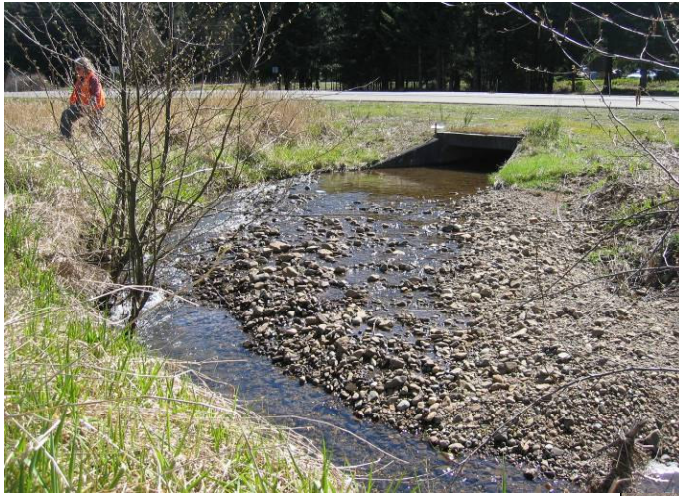
This culvert is a 140 foot long, six foot (span) by four foot (rise) concrete box culvert with flared wingwalls (Figure 3). This culvert was installed at the time SR 8 was built (around 1960). Culvert gradient is 2.3 percent. The culvert shows wear from age and recurrent sediment abrasion; structural soundness of the culvert is unknown. There is a similar six foot by four foot concrete box culvert (gradient unknown) owned by Thurston County 85 feet upstream.

◀ Culvert Outlet (Summer 2006)

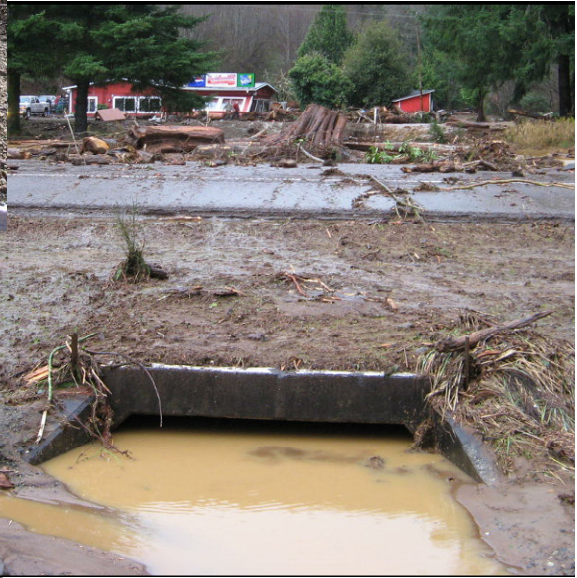
Sediment deposition to within six to 12 inches of the culvert soffit occurs one or more times per winter. Excess sediment is excavated as required by WSDOT maintenance crews under the general HPA for culvert maintenance. Because this general HPA limits excavation quantity to 50 cubic yards per occurrence, sediment is removed only from the culvert inlet and outlet. Accumulated sediment within the culvert remains, unless incidentally flushed out by natural flow.

Culvert Outlet (12/3/2006) ▶

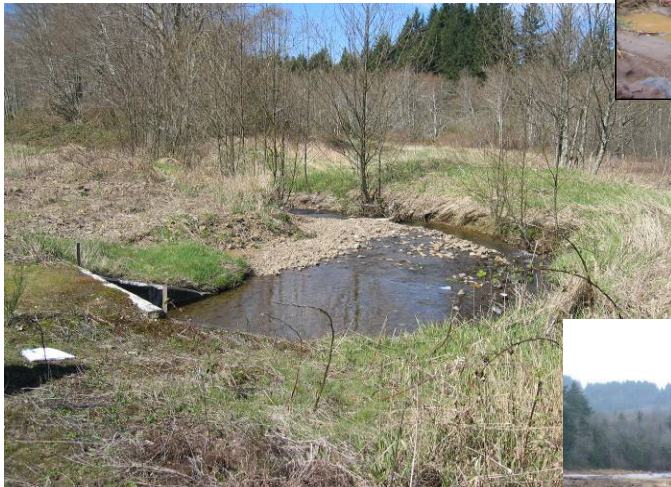
Immediately downstream of the CED culvert, the channel makes a 90 degree bend to the left (west) and flows in a channelized section along the right-of-way fence line for approximately 150 feet. This channel modification was probably done to allow for the shortest culvert length across SR 8 when it was originally built; the original channel alignment was likely skewed more to the west.

◀ Channel downstream of culvert  
(Summer 2006)

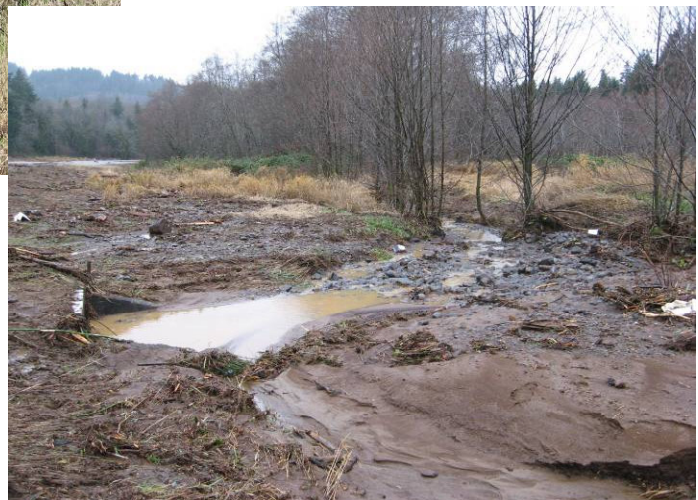
Channel banks immediately upstream and downstream of the CED and county culverts appeared to be in good condition prior to the debris torrent, with grass, shrubs and alder growing nearly continuously to the water line. There was some minor erosion along the outside of the 90 degree bend below the CED culvert. After the torrent, banks upstream of the county culvert were scoured by the hyper-concentrated flows of water, sediment and debris. Downstream of the county culvert, extensive deposits of fine sediment inundated the channel and will be subject to erosion by subsequent flows unless they are excavated and the exposed banks are revegetated.

Channel downstream of culvert ▶  
(12/3/2006)

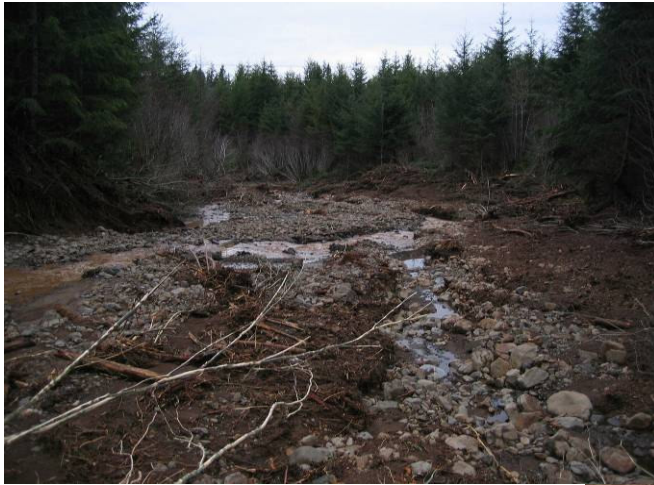
On December 3, 2007, a debris torrent originating in the upper part of the watershed (Figure 1) delivered large quantities of sediment (ranging in size from silt and sand to boulders) and woody debris to the site (Figure 4). Observers reported the wall of debris to be “100 feet wide and 15 feet high” (Ranch House BBQ website – [www.ranchhousebbq.net](http://www.ranchhousebbq.net)) as it collided with the county culvert immediately upstream from the site and heavily damaged the adjacent Ranch House Barbeque restaurant. Runout of the debris onto SR 8 appears to substantiate the size and destructive power of the torrent. Obstruction of the county culvert and a portion of the channel upstream resulted in diversion of most of the flow over the county road and eastbound lanes of SR 8 and into the median, where it was conveyed to the next several culverts to the west. The CED culvert was almost completely filled with sediment, and mud and debris (including booths from the restaurant dining room) littered both eastbound and westbound lanes of SR 8, necessitating a two-day road closure. While sediment obstructing the inlet and the outlet of the CED culvert was excavated by WSDOT maintenance crews, there is currently (as of the date of this memo) a partial obstruction within the culvert, which requires most of the flow to continue to be diverted to the west.

◀ Debris torrent track approximately 0.6 mi above CED site

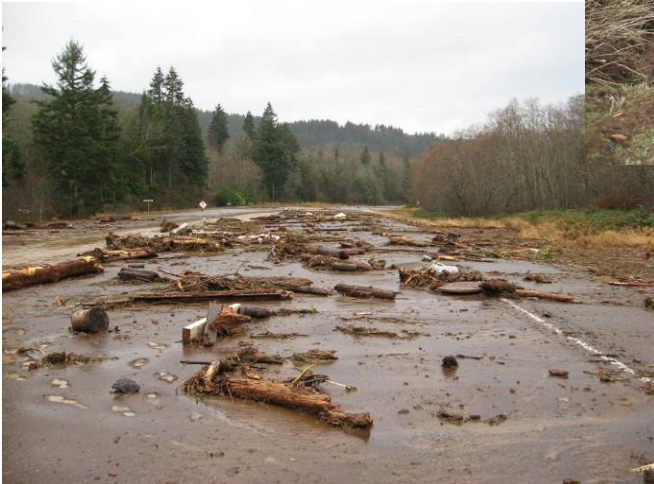
Sediment deposition between CED > culvert (in background) and county culvert

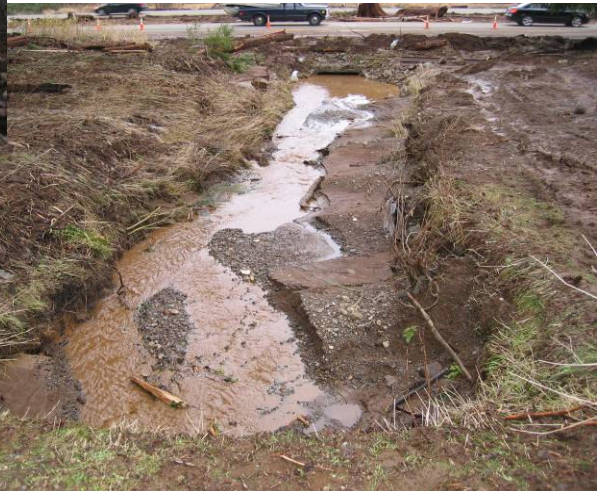
◀ Runout of debris onto westbound SR 8

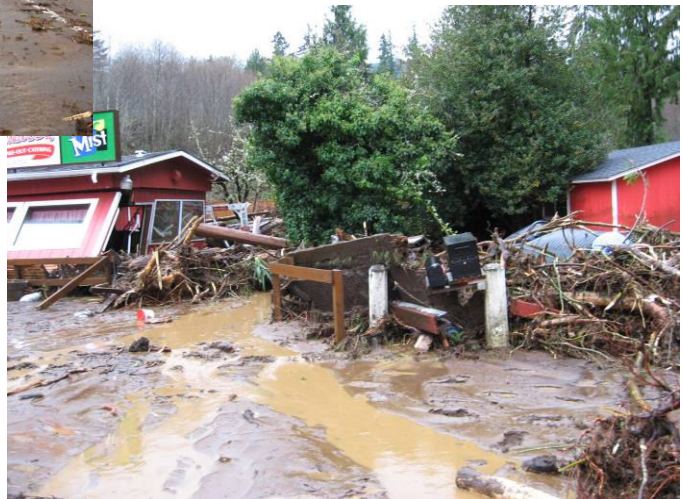
Debris accumulation behind county > culvert and damage to Ranch House Barbeque restaurant

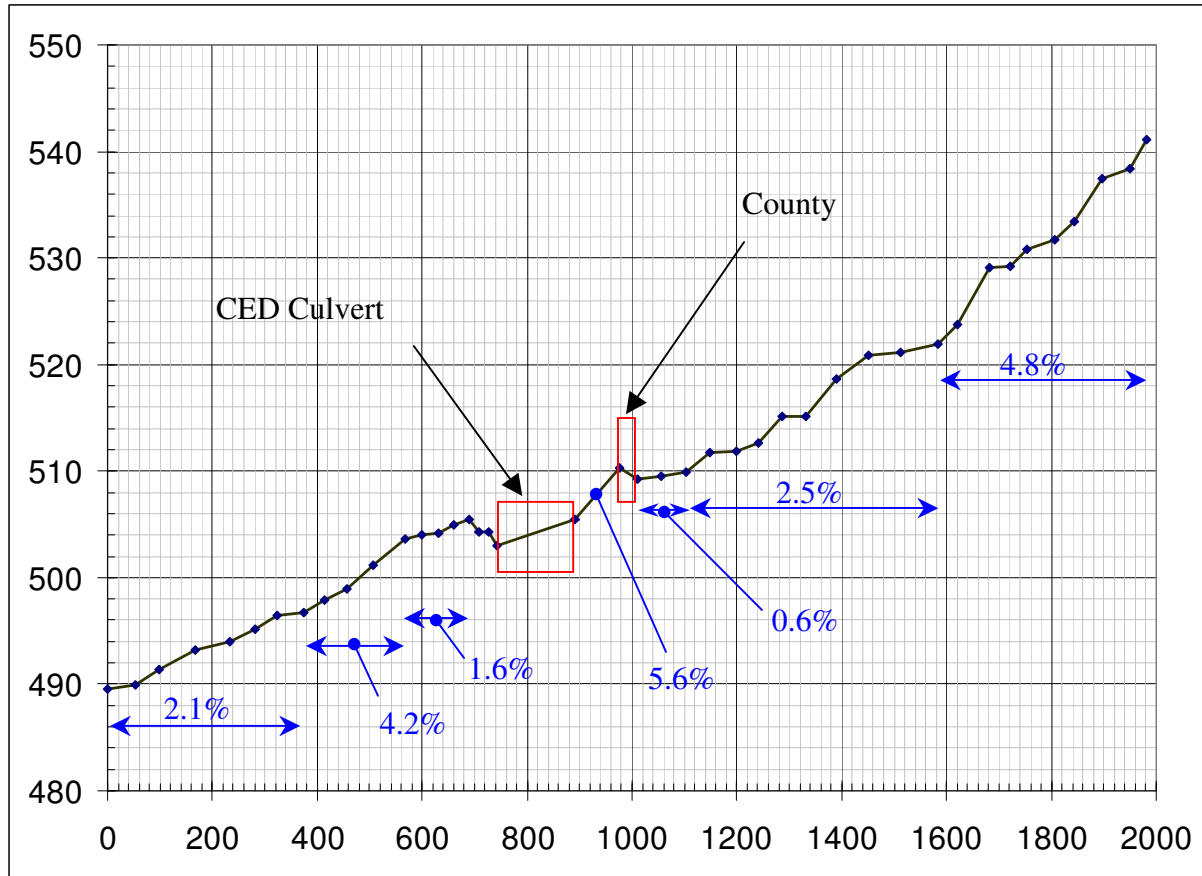
**Figure 5. Streambed Profile.**

Both the county and CED culverts are located along a gradient break as the creek emerges from the Black Hills onto the valley floor (Figure 5). Channel gradient decreases from 4.8 percent to 2.5 percent at 570 feet above the county culvert inlet and then to 0.6 percent at a point 90 feet above the inlet. Between the county and CED culverts, there is a moderately steep run of 5.6 percent for 90 feet. Below the downstream control (gravel bar) downstream of the culvert, the gradient is 1.9 percent for 150 feet, increasing to 4.2 percent for 110 feet before decreasing to 2.1 percent for the remaining 450 feet to a tributary confluence. [Note: Gradients on right-of-way were determined by survey; gradients off right-of-way are based on LIDAR imagery and may not reflect current conditions.]

- 2) Realignment of the channel below the CED culvert results in a 90 degree bend immediately below the CED culvert. This bend results in additional energy losses and sediment deposition immediately below the culvert outlet.
- 3) Both the county and CED culverts occur at/below gradient breaks (higher to lower), where sediment deposition would normally be expected to occur. The culverts are too small to accommodate this deposition and, in fact, exacerbate it through factors (1) and (2) above.

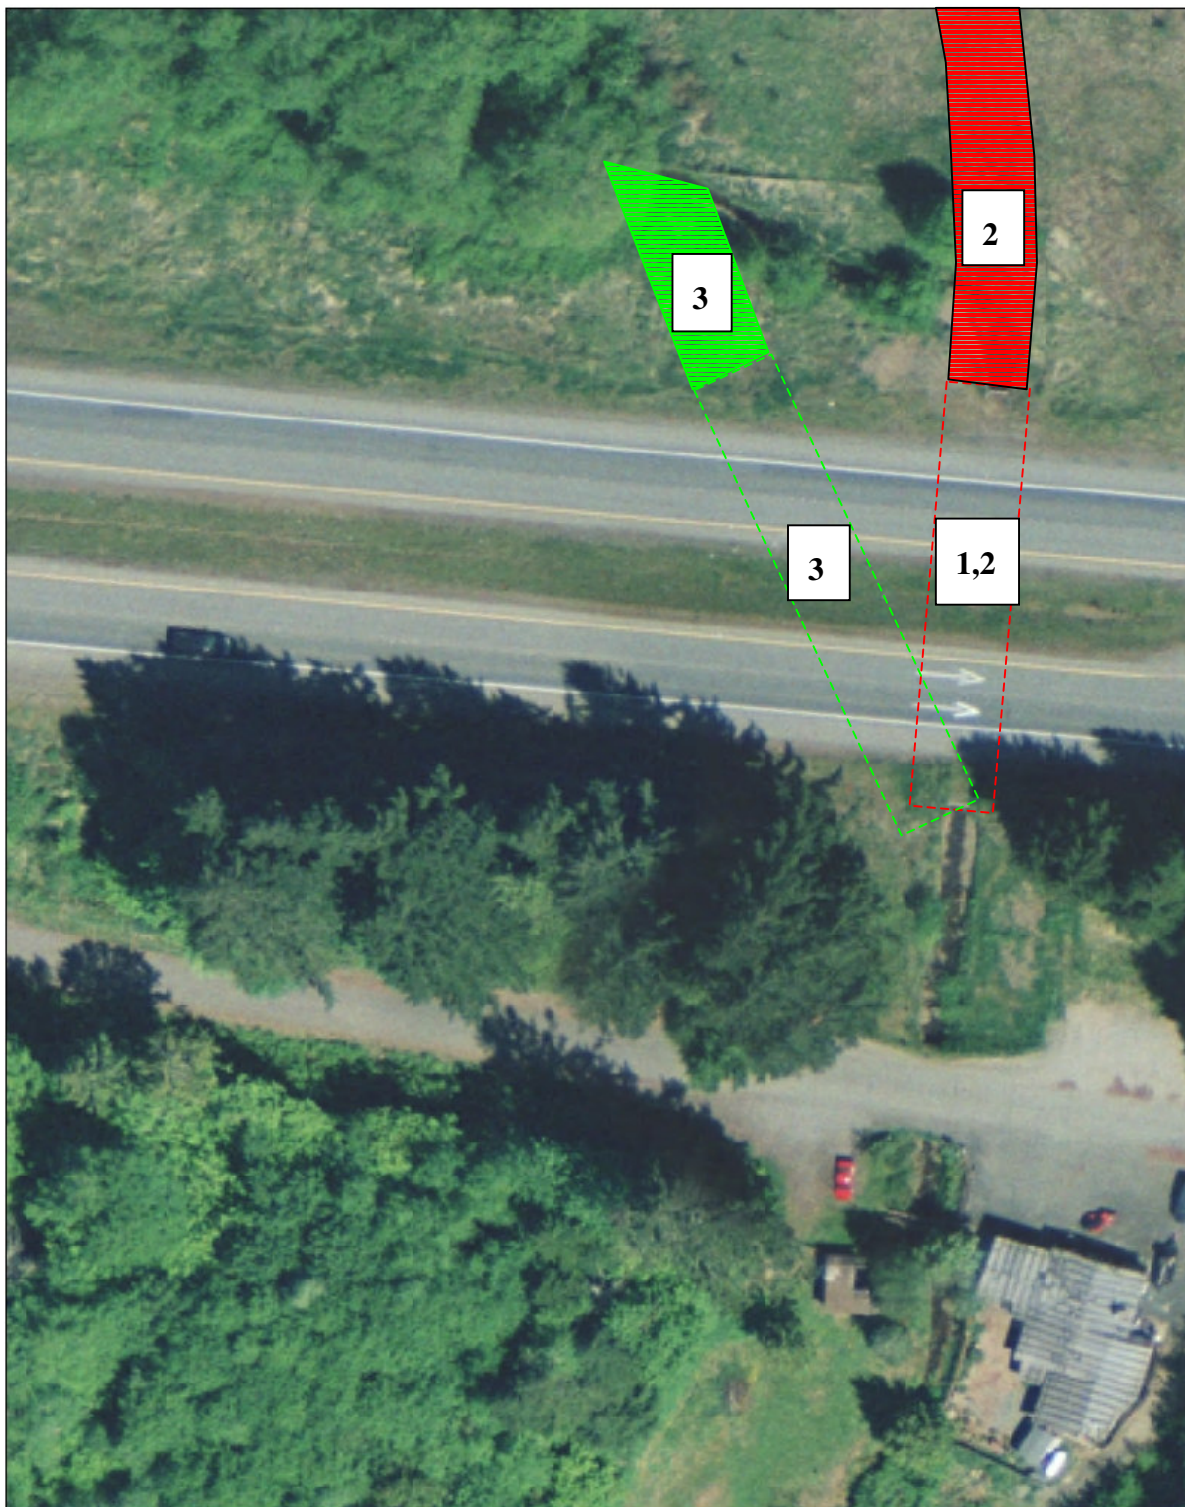
**Figure 6. Treatment alternatives for SR 8 MP 15.33 CED site.**

Three treatment alternatives were identified which would be expected to address one or more of the site-based factors identified above (see Figure 6). None of the alternatives proposed will address the identified reach-based factor (high sediment supply), which is out of WSDOT control. However, the alternatives should be able to accommodate the excess sediment to some degree. In developing the alternatives below, it is assumed that the county culvert remains in place.

This treatment alternative would replace the existing culvert with a larger concrete box or Con-Span-type structure at the same alignment and gradient (2.3 percent). The new culvert width will meet the stream simulation width requirement (at this site, approximately 20 feet). Because of the slope break (5.6 percent to 2.3 percent) at the entrance, a stable channel bed will be required, which may optionally transition into an “equilibrium” (i.e. transportable) bed downstream. The elevation of the channel bed in the culvert will correspond to the current level of deposition in the existing culvert. This will necessitate raising the roadway a minimum of four feet.

This treatment alternative would replace the culvert as described in Treatment Alternative 1 and eliminate the 90 degree bend by constructing a new channel through the pasture to the north of the right-of-way, connecting to the downstream tributary at (or upstream from) the existing tributary junction. The existing channel from the bend to the existing tributary junction downstream would be abandoned.

This treatment alternative would replace the existing culvert with a larger concrete box or Con-Span-type structure, skewing the alignment 30-35 degrees west relative to the existing alignment. Culvert length is estimated to be 160 - 200 feet, and culvert gradient is approximately two percent. The new culvert width will meet the stream simulation width requirement (at this site, approximately 20 feet). The elevation and gradation of the channel bed in the culvert will be based on the result of hydraulic analysis (i.e. HEC-RAS modeling); it is expected that the roadway will need to be raised a minimum of four feet. Below the realigned culvert, approximately 100-150 feet of new channel will be constructed, and the existing channel between the culvert outlet and the new channel will be abandoned. Some minor acquisition of right-of-way may be required, depending on the final alignment and design of the channel. *This alternative is recommended, because it addresses all of the site-based factors and does not require substantial acquisition of new right-of-way.*
